# SEWER SYSTEM MANAGEMENT PLAN

**San Bernardino Community College District**

June 2016

**Prepared by:  
ITF & Associates Inc.  
11278 Los Alamitos Blvd., #354  
Los Alamitos, CA 90720  
(800) 797-9483**

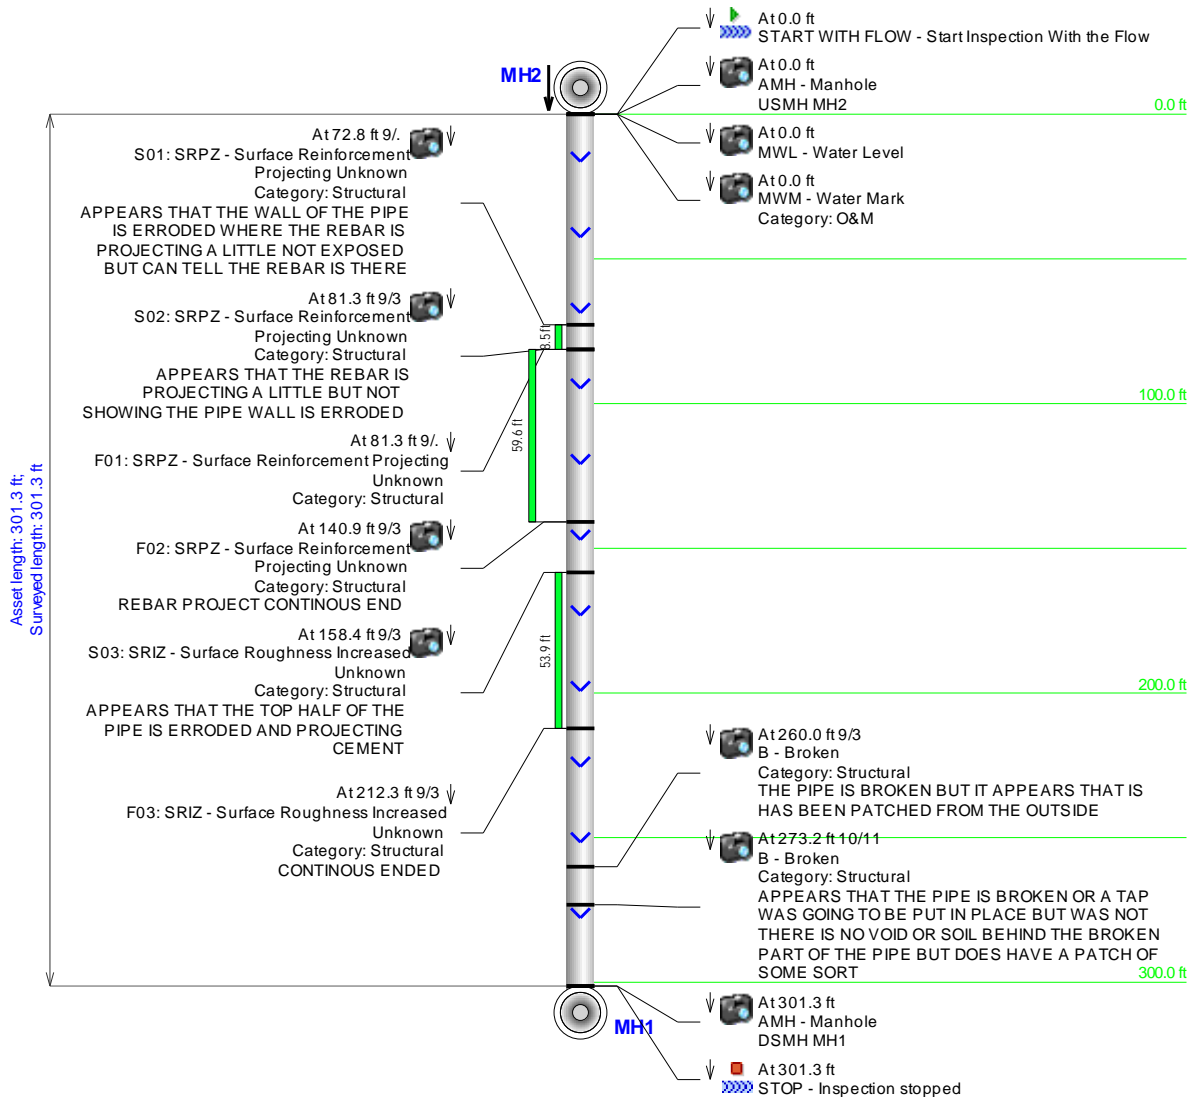
## Main Inspection with Pipe-Run and Scoring

Project Name:	Pipeline segment ref:	City:	Street:
CRAFTON HILLS COLLEGE	MH2-MH1	YUCAIPA	CAMPUS DRIVE
Start date/time:	Width:	Height:	Material:
9/29/2015		8	RCP
Direction:	Length surveyed:	Weather:	Media label:
Downstream	301.3	1

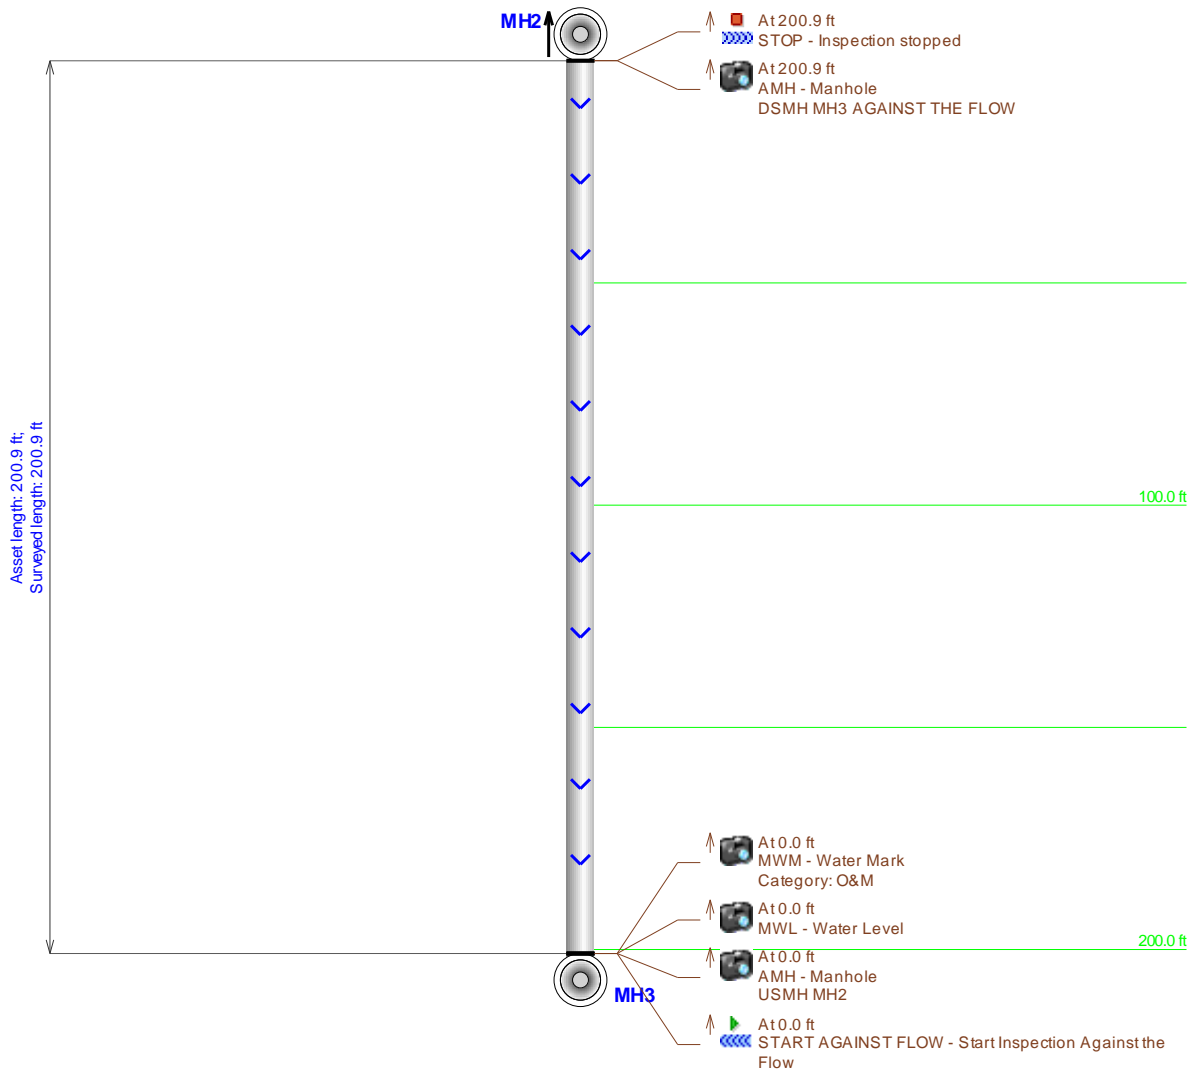
## Main Inspection with Pipe-Run and Scoring

Project Name:	Pipeline segment ref:	City:	Street:
CRAFTON HILLS COLLEGE	MH2-MH3	YUCAIPA	CAMPUS DRIVE
Start date/time:	Width:	Height:	Material:
9/29/2015		8	RCP
Location code:			
C			
Direction:	Length surveyed:	Weather:	Media label:
UPSTREAM	200.9	1

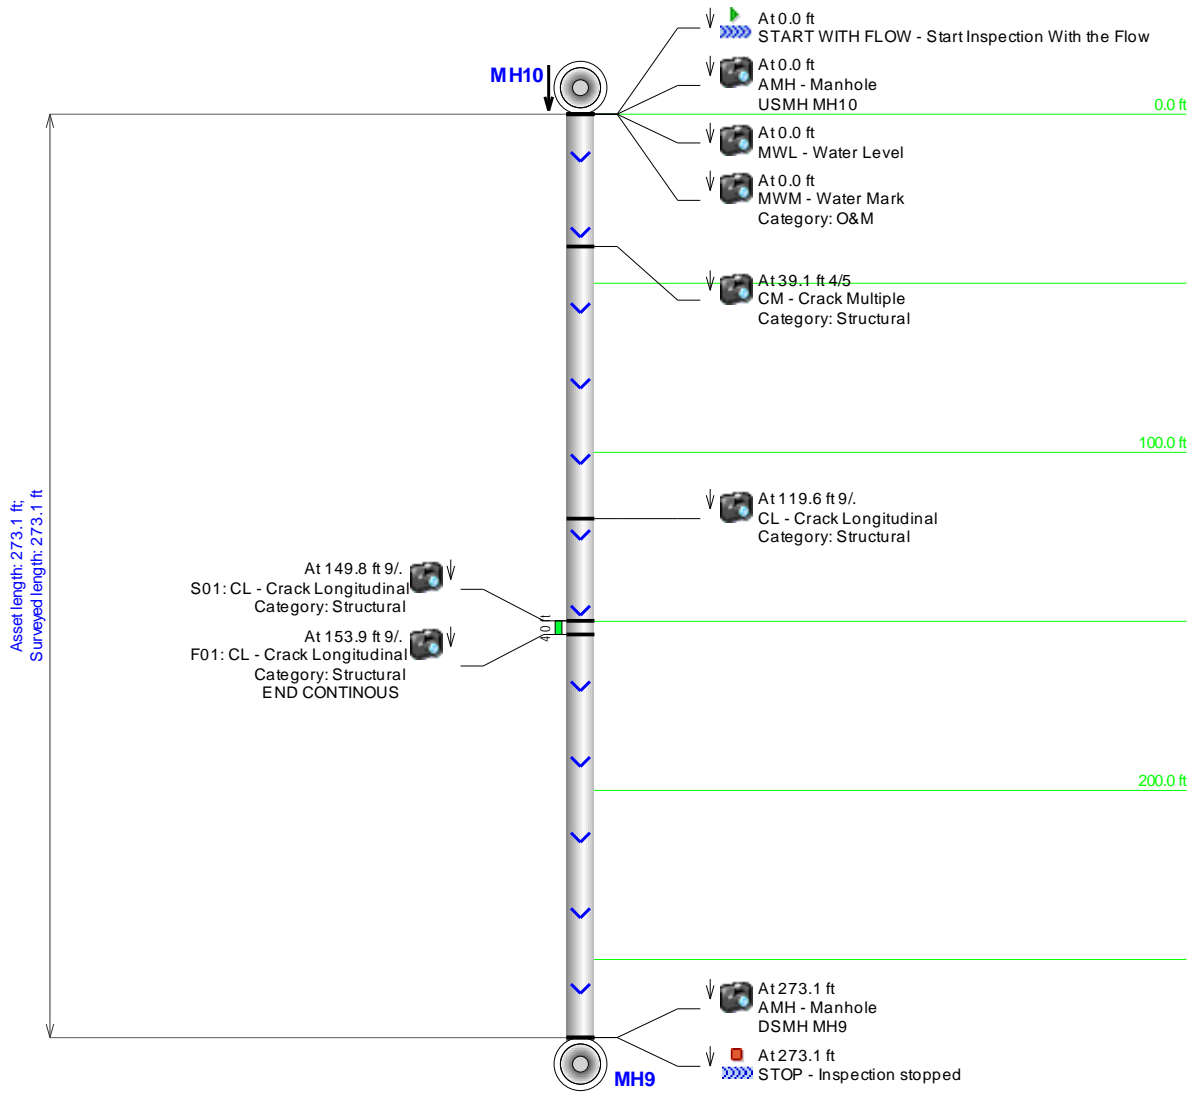
## Main Inspection with Pipe-Run and Scoring

Project Name:	Pipeline segment ref:	City:	Street:
CRAFTON HILLS COLLEGE	MH10-MH9	YUCAIPA	CAMPUS DR
Start date/time:	Width:	Height:	Material:
9/29/2015		8	RCP
Location code:	Direction:	Length surveyed:	Weather:
C	Downstream	273.1	1
Media label:

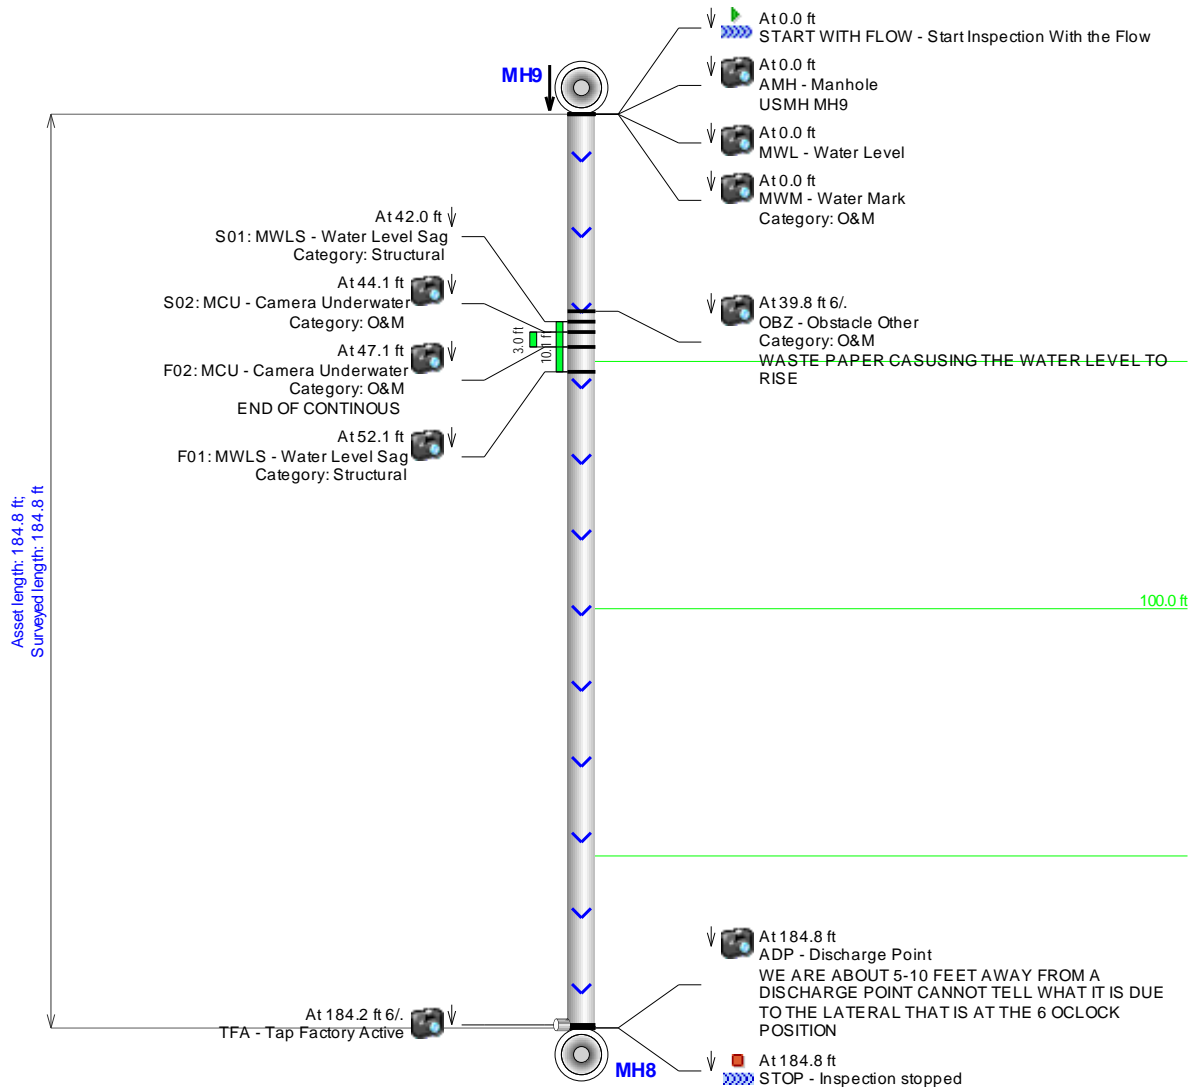
## Main Inspection with Pipe-Run and Scoring

Project Name:	Pipeline segment ref:	City:	Street:
CRAFTON HILLS COLLEGE	MH9-MH8	YUCAIPA	CAMPUS DRIVE
Start date/time:	Width:	Height:	Material:
9/29/2015		8	RCP
Location code:	Direction:	Length surveyed:	Weather:
C	Downstream	184.8	1
Media label:

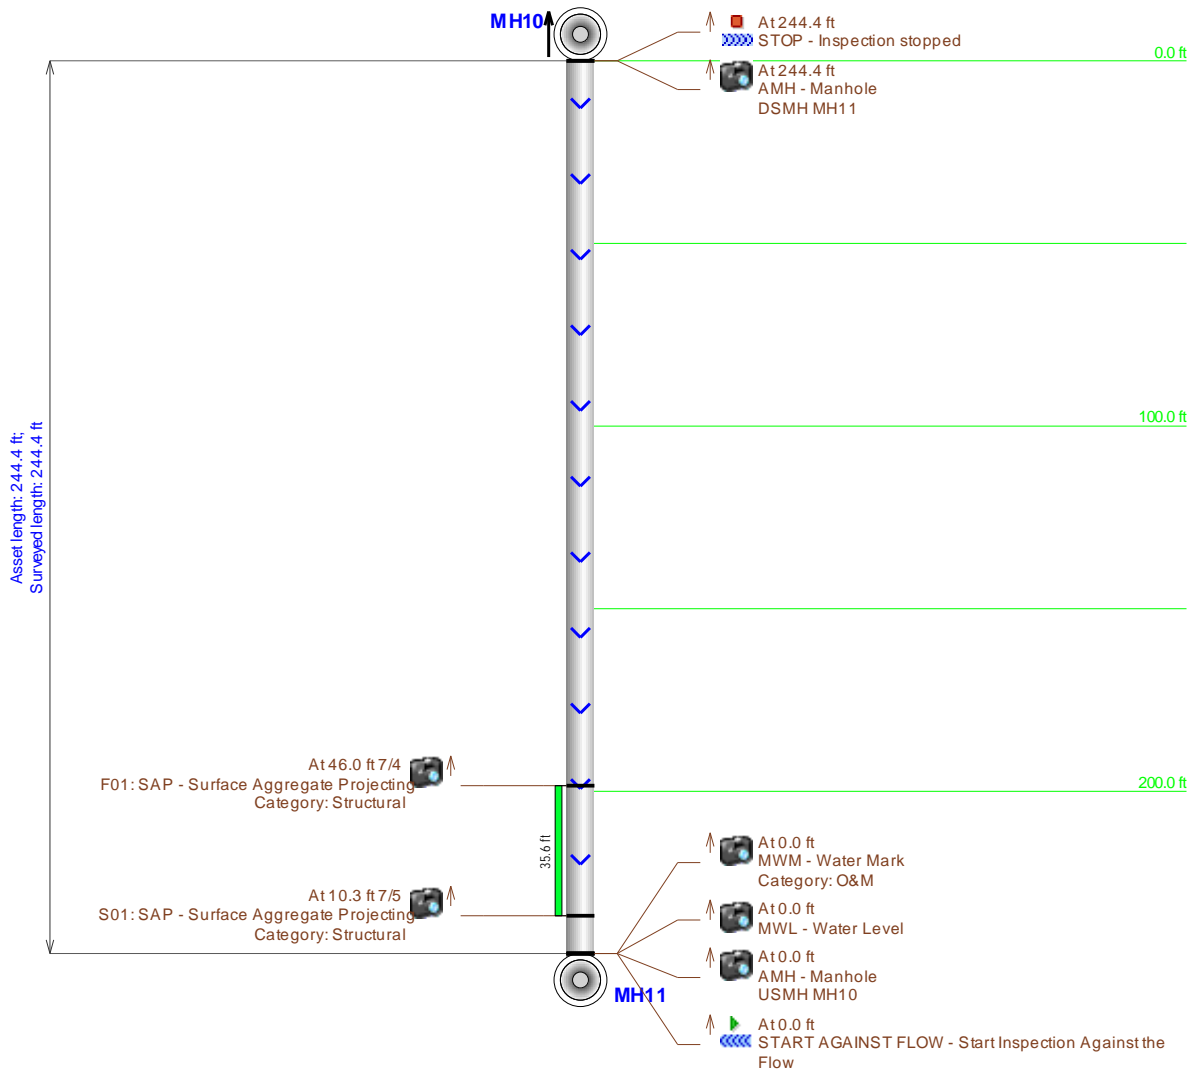
## Main Inspection with Pipe-Run and Scoring

Project Name: <b>CRAFTON HILLS COLLEGE</b>	Pipeline segment ref: <b>MH10-MH11</b>	City: <b>YUCAIPA</b>	Street: <b>CAMPUS DRIVE</b>
Start date/time: <b>9/29/2015</b>	Width: <b></b>	Height: <b>8</b>	Material: <b>RCP</b>
Location code: <b>C</b>	Direction: <b>UPSTREAM</b>	Length surveyed: <b>244.4</b>	Weather: <b>1</b>
		Media label: <b></b>

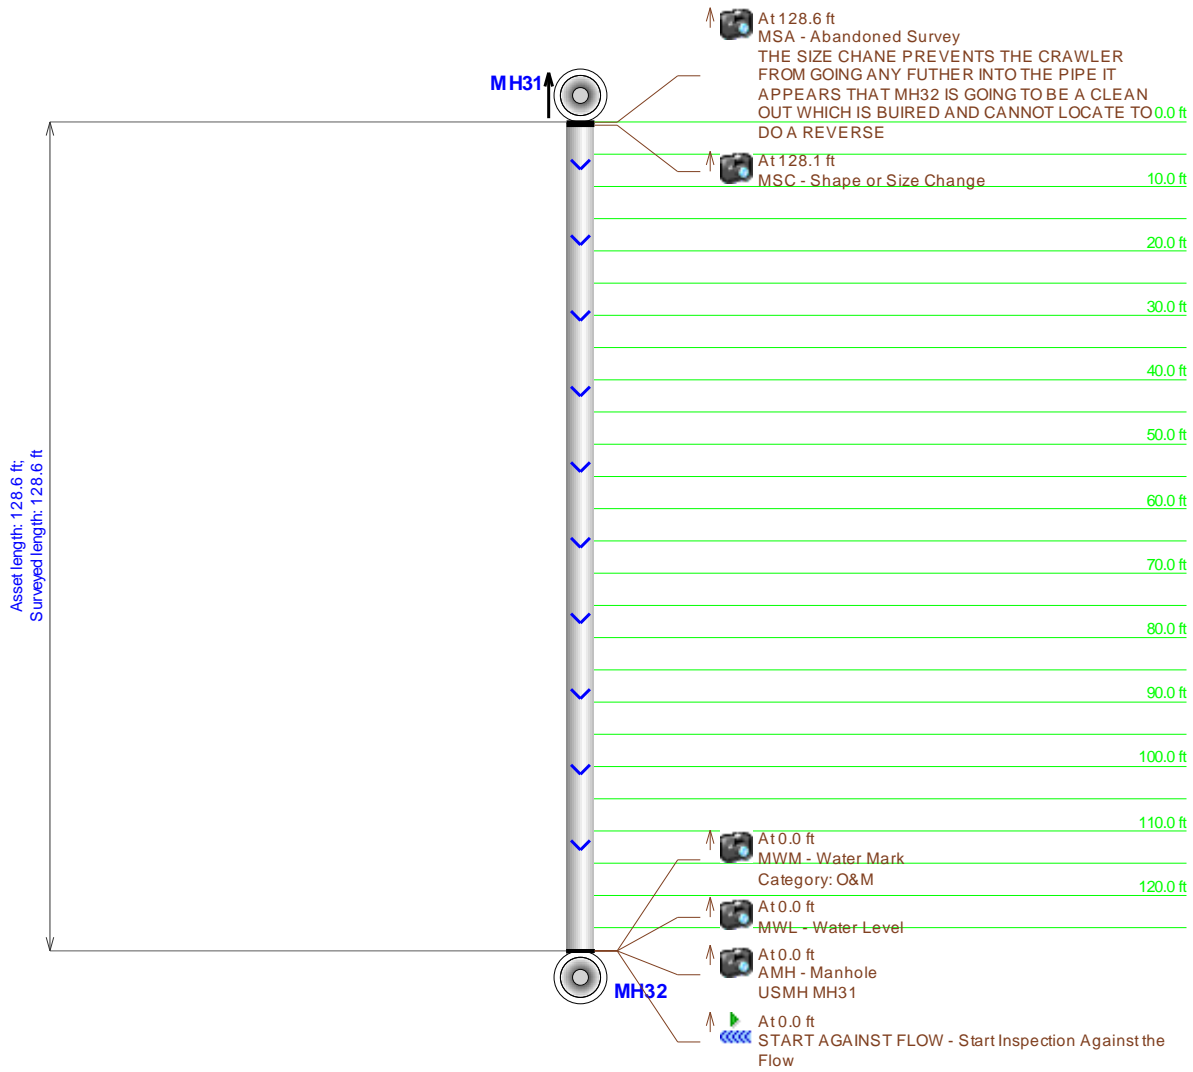
## Main Inspection with Pipe-Run and Scoring

Project Name:	Pipeline segment ref:	City:	Street:
CRAFTON HILLS COLLEGE	MH31-MH32	YUCAIPA	CRAFTON HILLS MATIENCE ROAD
Start date/time:	Width:	Height:	Material:
9/29/2015		8	PVC
Direction:	Length surveyed:	Weather:	Media label:
UPSTREAM	128.6	1

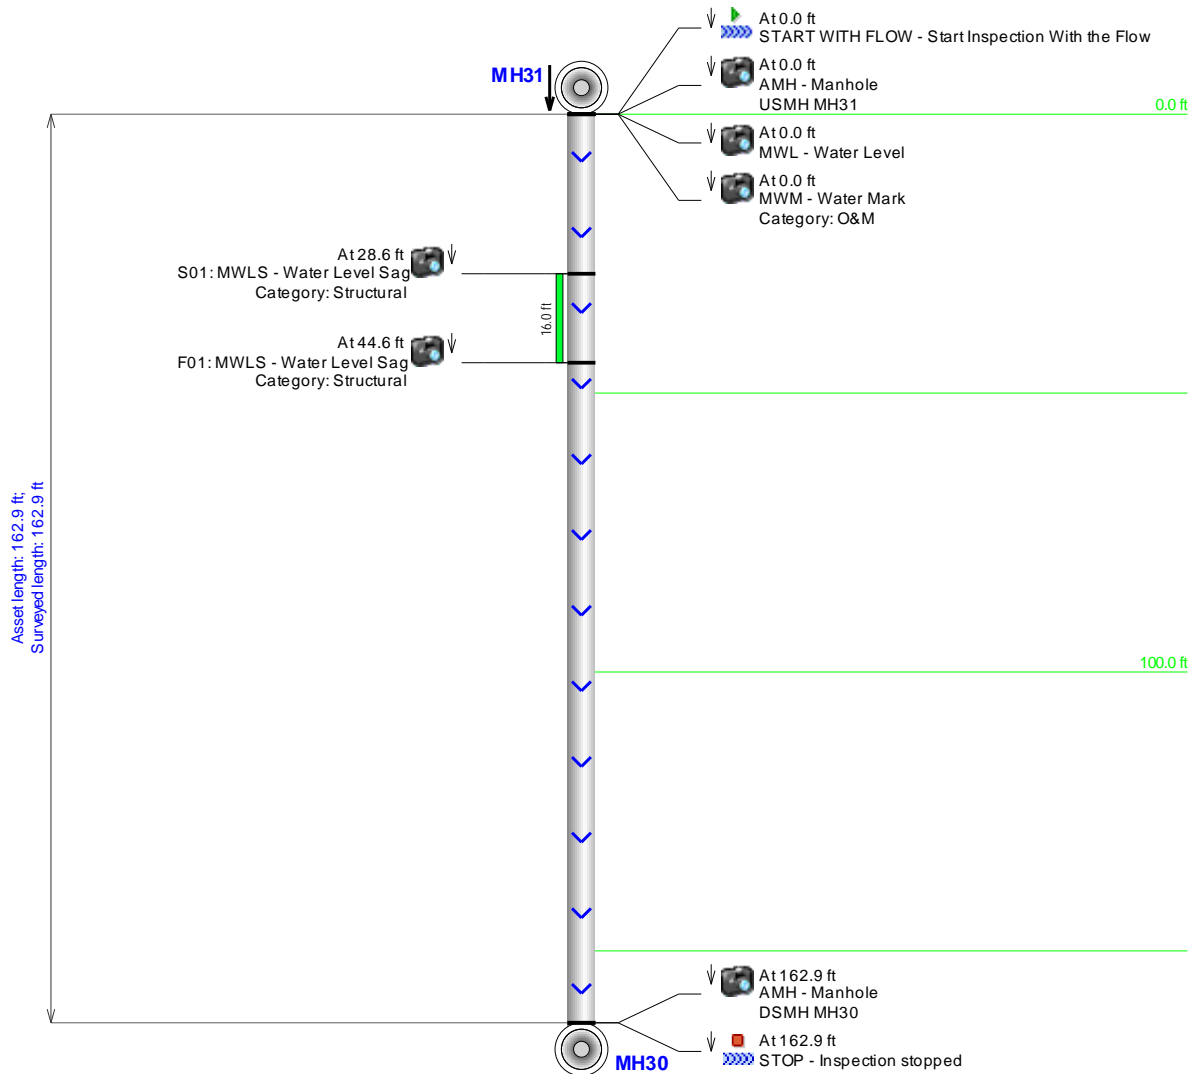
## Main Inspection with Pipe-Run and Scoring

Project Name:	Pipeline segment ref:	City:	Street:
CRAFTON HILLS COLLEGE	MH31-MH30	YUCAIPA	MATIENCE ROAD
Start date/time:	Width:	Height:	Material:
9/29/2015		8	PVC
Direction:	Length surveyed:	Weather:	Media label:
Downstream	162.9	1

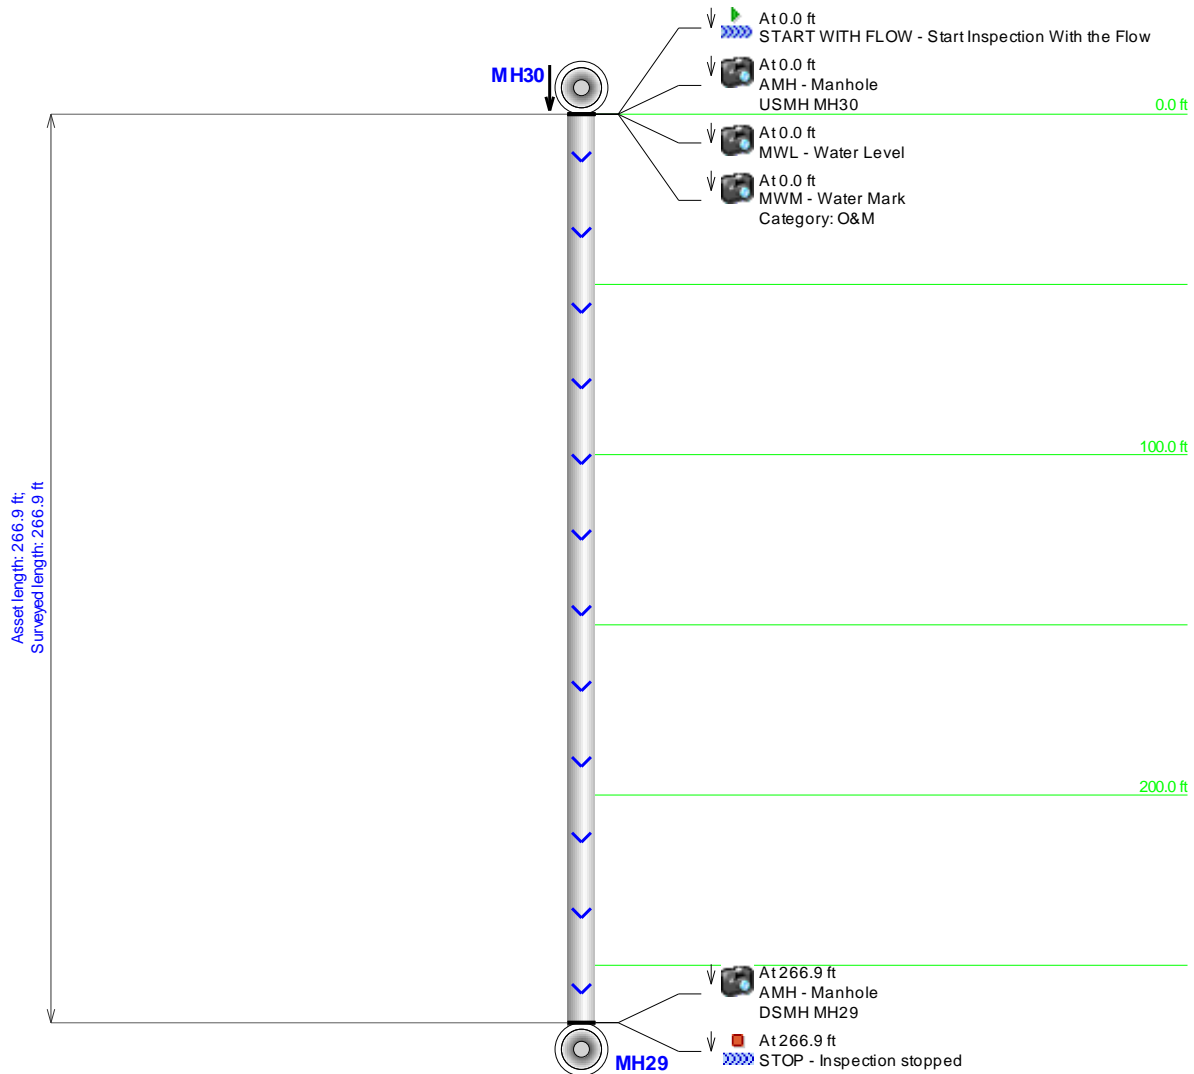
## Main Inspection with Pipe-Run and Scoring

Project Name: <b>CRAFTON HILLS COLLEGE</b>	Pipeline segment ref: <b>MH30-MH29</b>	City: <b>YUCAIPA</b>	Street: <b>CRAFTON HILLS MATIENCE ROAD</b>
Start date/time: <b>9/29/2015</b>	Width: <b></b>	Height: <b>8</b>	Material: <b>PVC</b>
Direction: <b>Downstream</b>	Length surveyed: <b>266.9</b>	Weather: <b>1</b>	Location code: <b>C</b>
			Media label: <b></b>

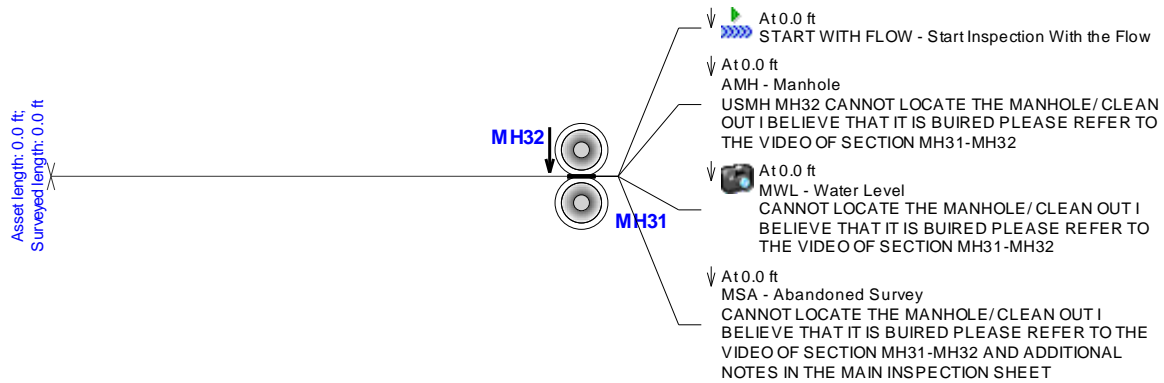
## Main Inspection with Pipe-Run and Scoring

Project Name: <b>CRAFTON HILLS COLLEGE</b>	Pipeline segment ref: <b>MH32-MH31</b>	City: <b>YUCAIPA</b>	Street: <b>CRAFTOM HILLS MATIENCE ROAD</b>
Start date/time: <b>9/30/2015</b>	Width: <b></b>	Height: <b>8</b>	Material: <b>PVC</b>
Location code: <b>C</b>	Direction: <b>Downstream</b>	Length surveyed: <b>0.0</b>	Weather: <b>1</b>
			Media label: <b></b>

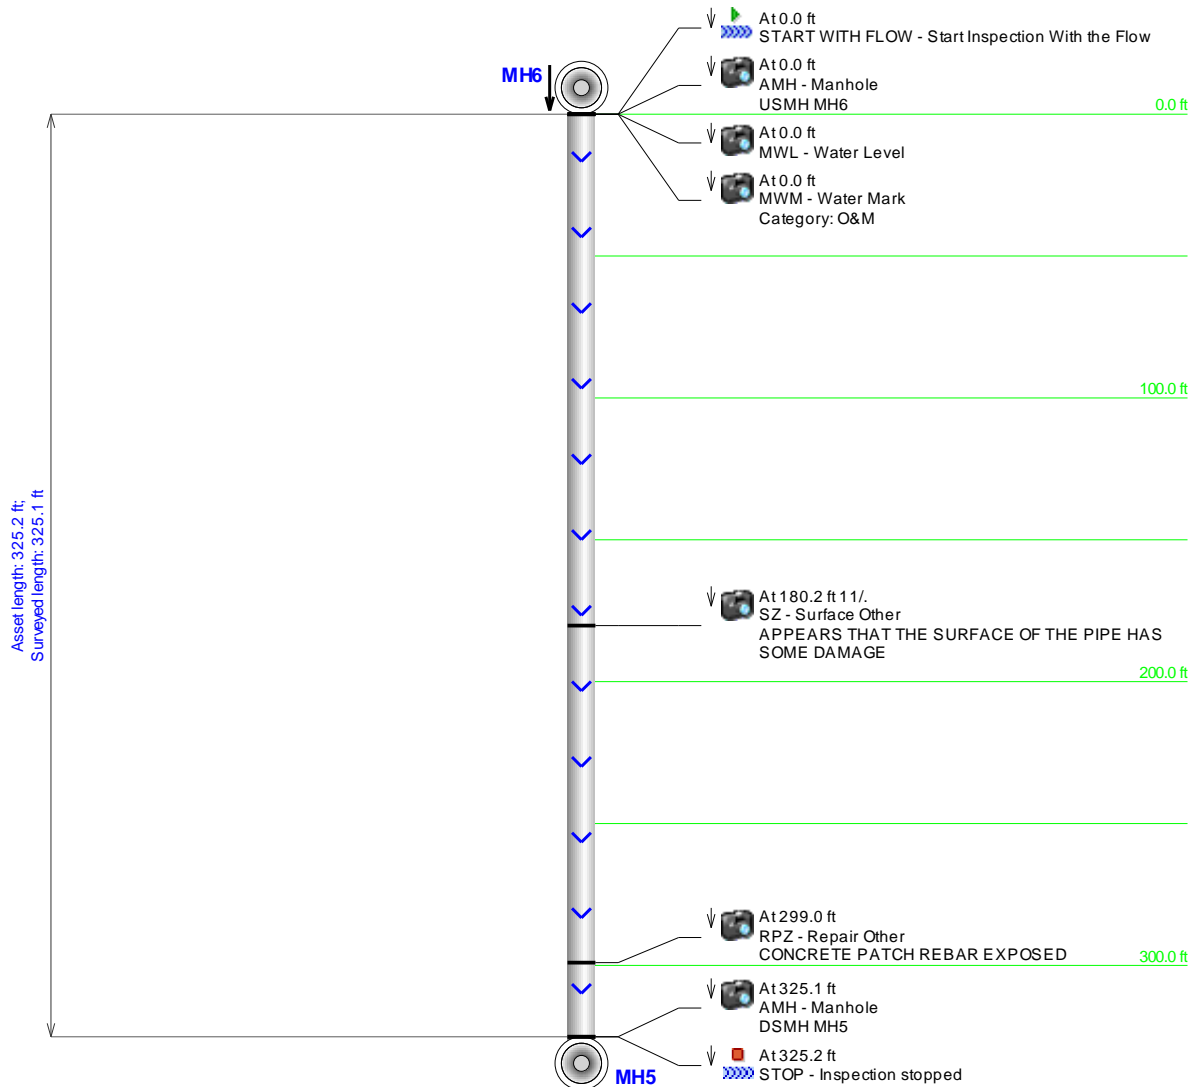
## Main Inspection with Pipe-Run and Scoring

Project Name: <b>CRAFTON HILLS COLLEGE</b>	Pipeline segment ref: <b>MH6-MH5</b>	City: <b>YUCAIPA</b>	Street: <b>CAMPUS DRIVE</b>
Start date/time: <b>10/3/2015</b>	Width: 	Height: <b>8</b>	Material: <b>RCP</b>
Direction: <b>Downstream</b>	Length surveyed: <b>325.1</b>	Weather: <b>1</b>	Location code: <b>C</b>
			Media label:

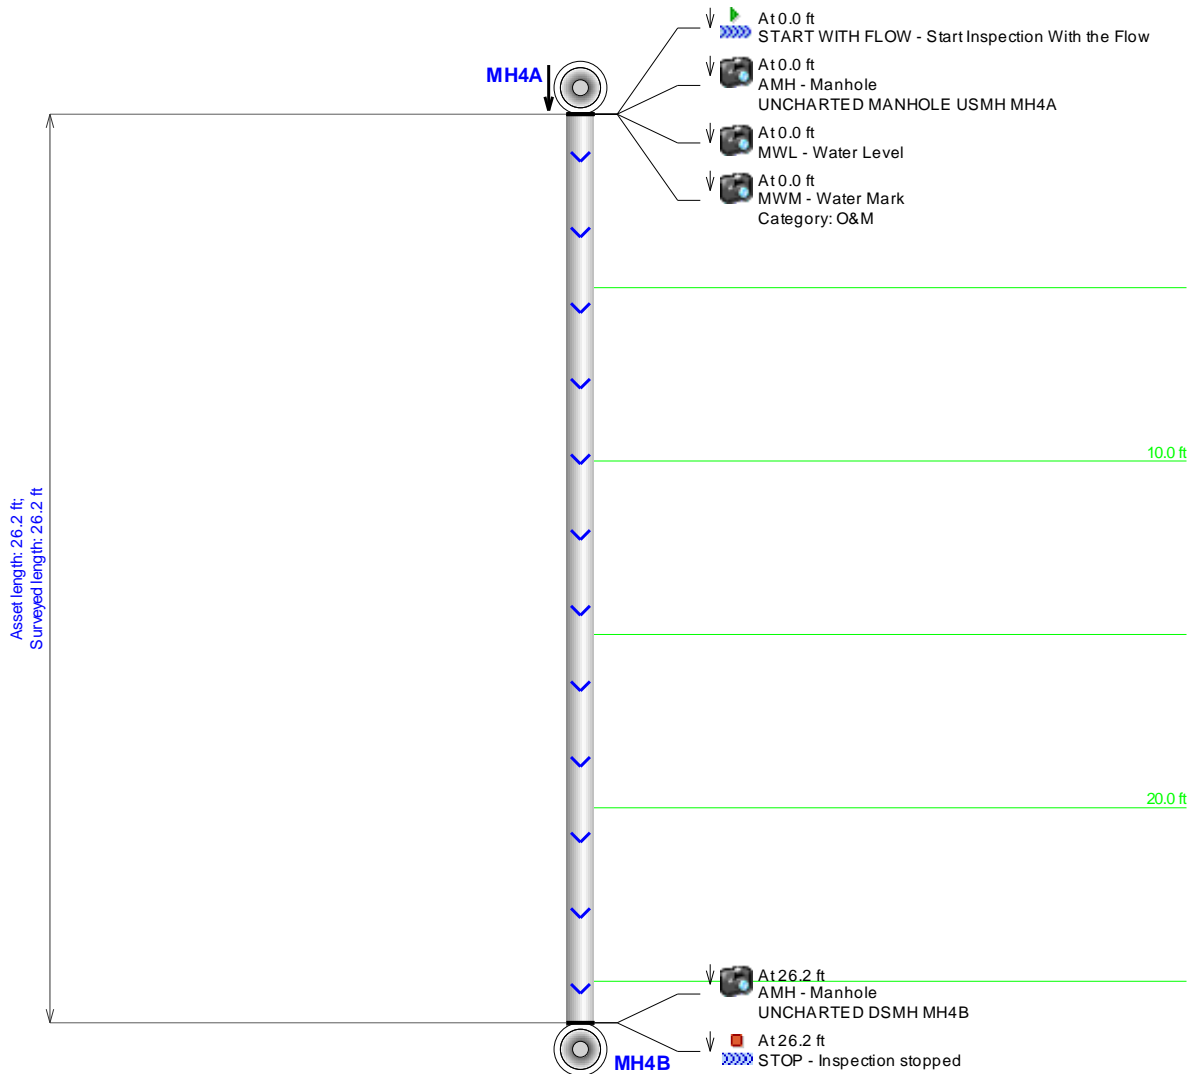
## Main Inspection with Pipe-Run and Scoring

Project Name:	Pipeline segment ref:	City:	Street:
CRAFTON HILLS COLLEGE	MH4A-MH4B	YUCAIPA	CAMPUS DRIVE AND EMERAL VIEW
Start date/time:	Width:	Height:	Material:
10/3/2015		8	RCP
Direction:	Length surveyed:	Weather:	Media label:
Downstream	26.2	1

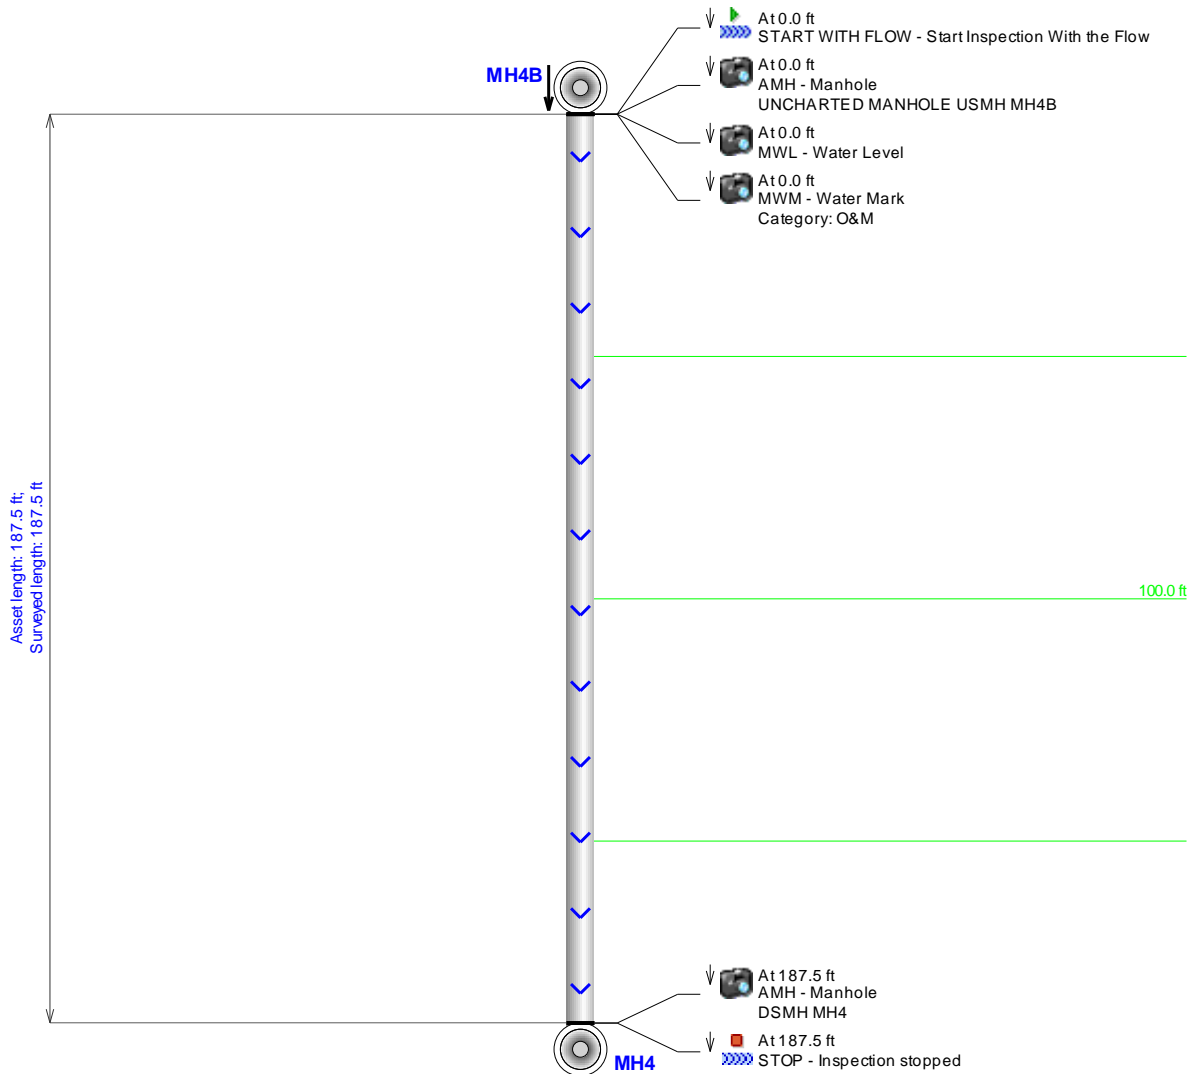
## Main Inspection with Pipe-Run and Scoring

Project Name: <b>CRAFTON HILLS COLLEGE</b>	Pipeline segment ref: <b>MH4B-MH4</b>	City: <b>YACAIPA</b>	Street: <b>CAMPUS DRIVE AND EMERALD VIEW</b>
Start date/time: <b>10/3/2015</b>	Width: <b></b>	Height: <b>8</b>	Material: <b>RCP</b>
Location code: <b>C</b>	Direction: <b>Downstream</b>	Length surveyed: <b>187.5</b>	Weather: <b>1</b>
			Media label: <b></b>

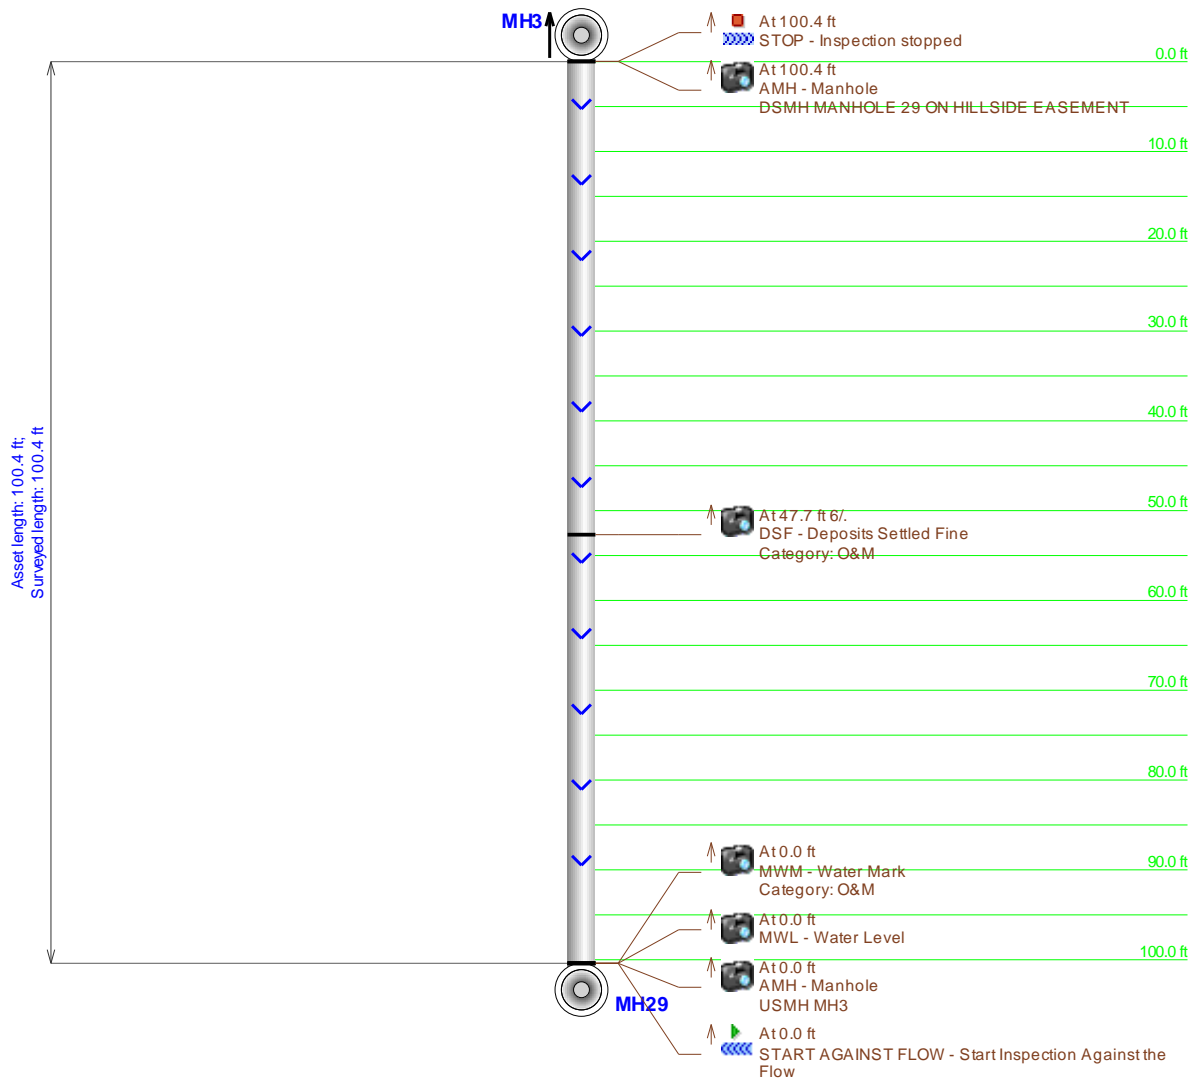
## Main Inspection with Pipe-Run and Scoring

Project Name: <b>CRAFTON HILLS COLLEGE</b>	Pipeline segment ref: <b>MH3-MH29</b>	City: <b>YUCAIPA</b>	Street: <b>CAMPUS ROAD AND CRAFTON HILLS MATIENCE ROAD</b>
Start date/time: <b>10/3/2015</b>	Width: 	Height: <b>8</b>	Material: <b>PVC</b>
Location code: <b>C</b>	Direction: <b>UPSTREAM</b>	Length surveyed: <b>100.4</b>	Weather: <b>1</b>
			Media label:

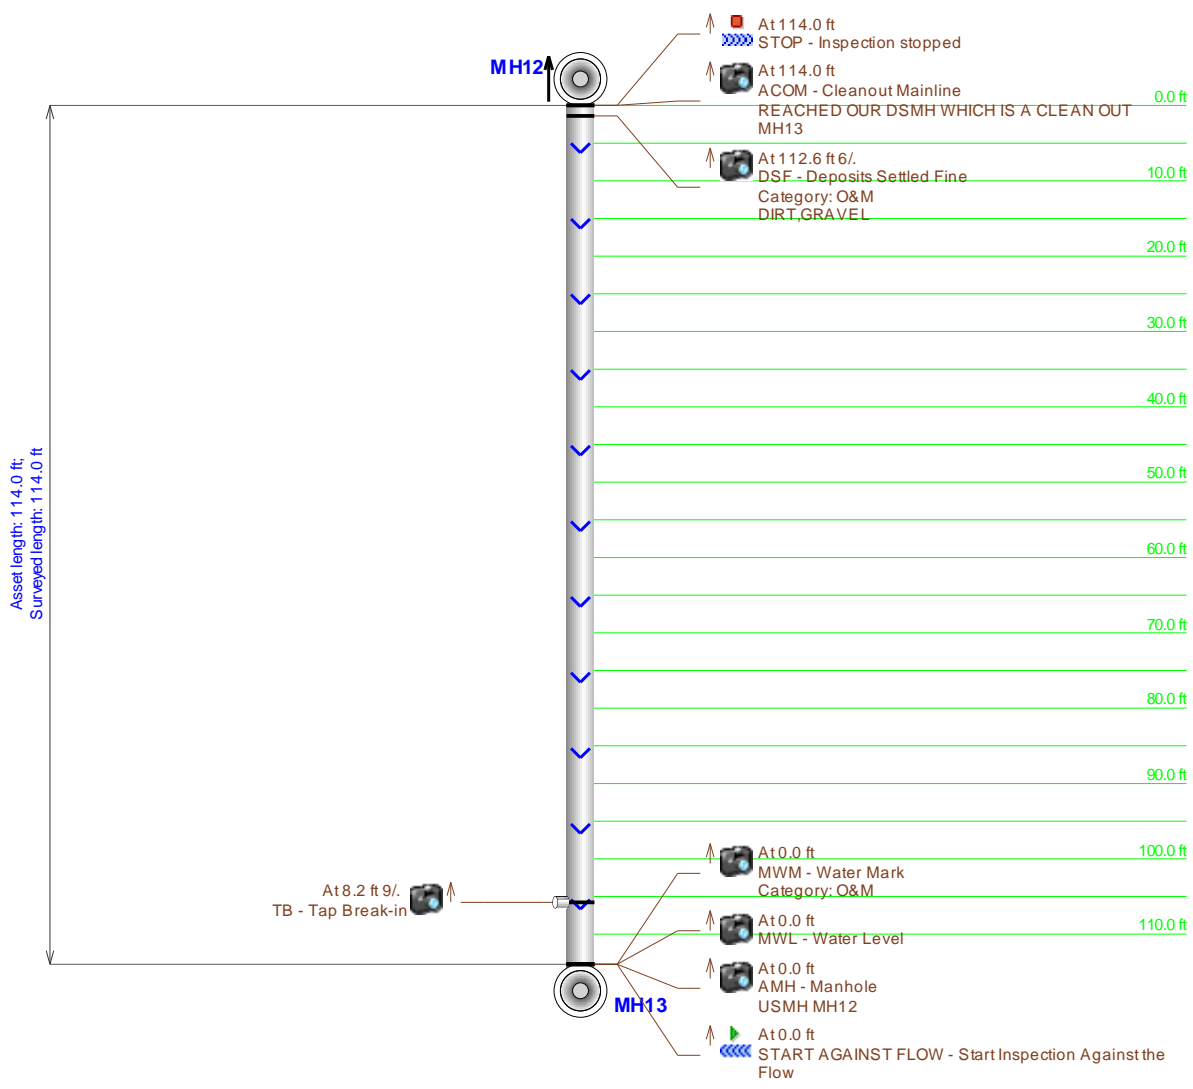
## Main Inspection with Pipe-Run and Scoring

Project Name:	Pipeline segment ref:	City:	Street:
CRAFTON HILLS COLLEGE	MH12-MH13	YUCAIPA	PARKING LOT B
Start date/time:	Width:	Height:	Material:
10/3/2015		8	RCP
Location code:	Direction:	Length surveyed:	Weather:
G	UPSTREAM	114.0	1
Media label:

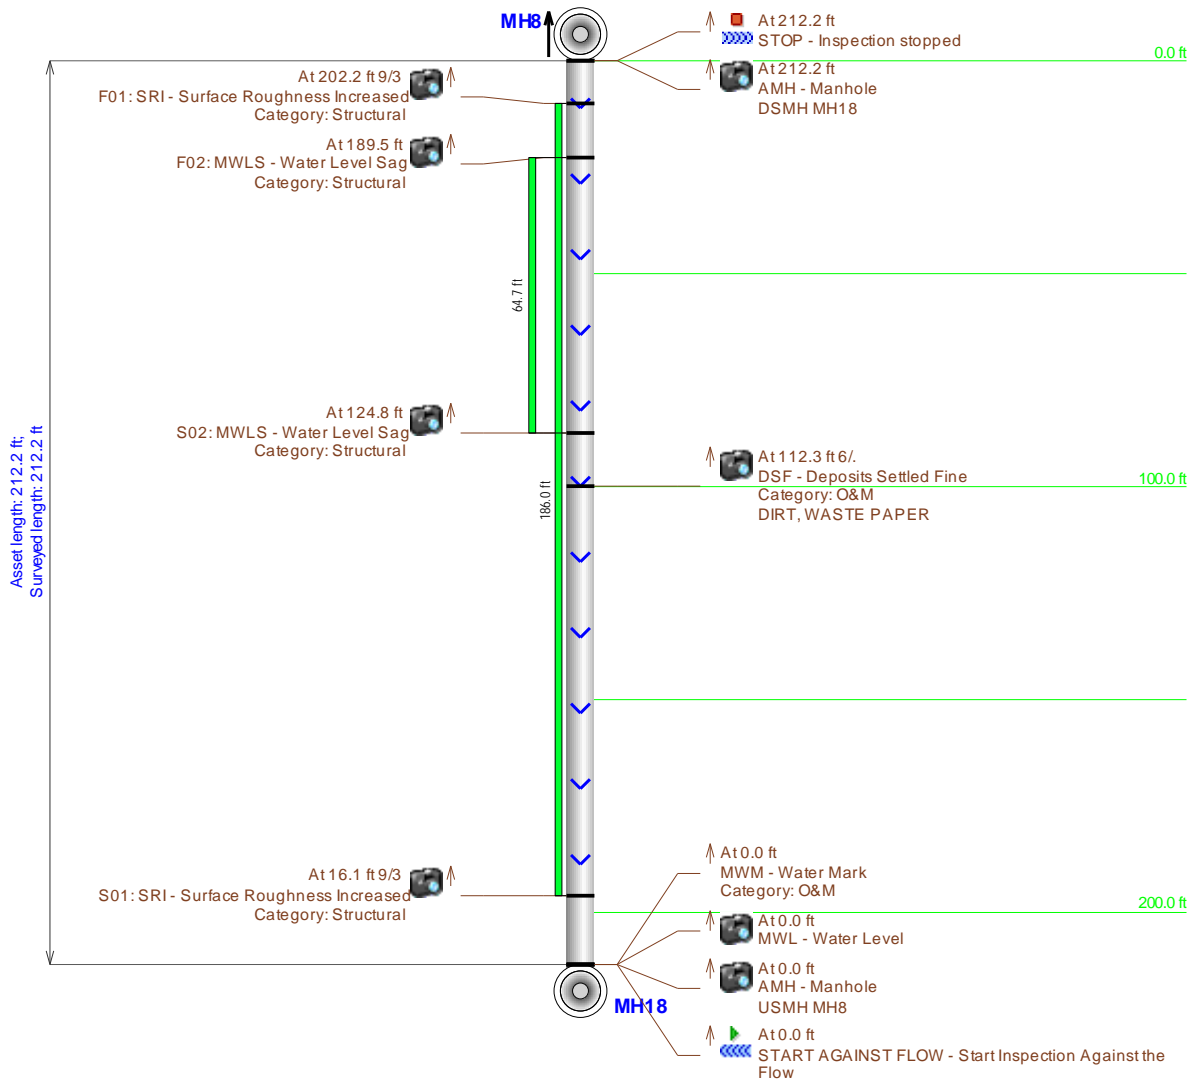
## Main Inspection with Pipe-Run and Scoring

Project Name:	Pipeline segment ref:	City:	Street:
CRAFTON HILLS COLLEGE	MH8-MH18	YUCAIPA	CAMPUS DRIVE-PARKING LOT D
Start date/time:	Width:	Height:	Material:
10/3/2015		8	RCP
Direction:	Length surveyed:	Weather:	Media label:
UPSTREAM	212.2	1

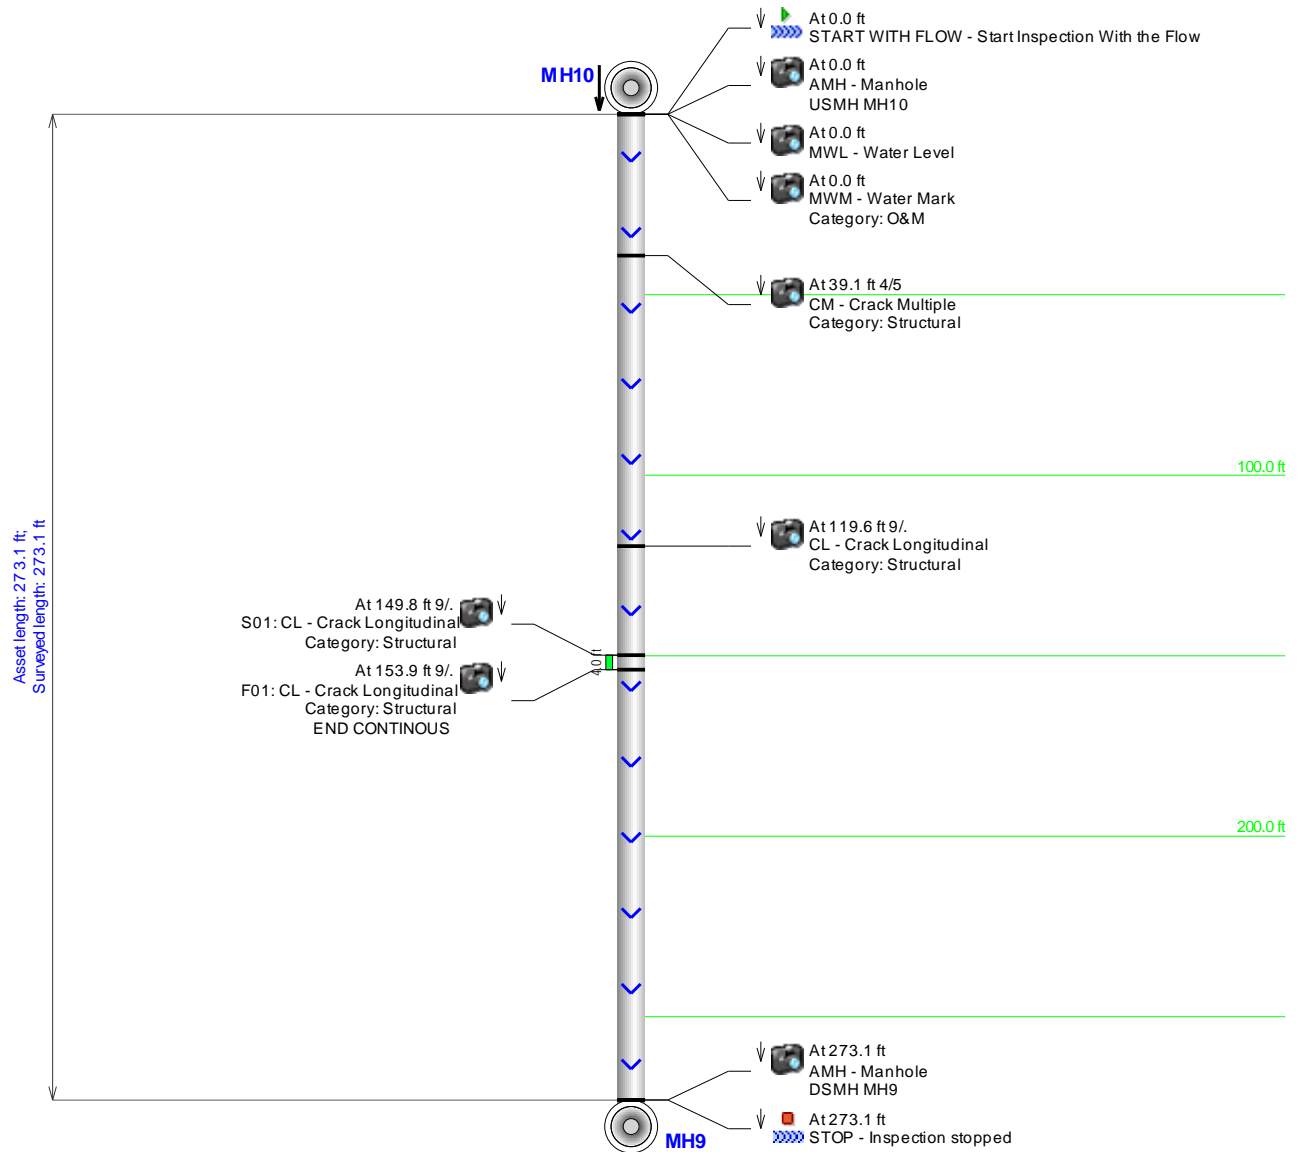
## Main Inspection with Pipe-Run Graph

Project Name: <b>CRAFTON HILLS COLLEGE</b>	Pipeline segment ref: <b>MH10-MH9</b>	City: <b>YUCAIPA</b>	Street: <b>CAMPUS DR</b>
Start date/time: <b>9/29/2015</b>	Width: 	Height: <b>8</b>	Material: <b>RCP</b>
Direction: <b>Downstream</b>	Length surveyed: <b>273.1</b>	Surveyed by: <b>R.ZIEGLER</b>	Location code: <b>C</b>
			Weather: <b>1</b>
Additional info:

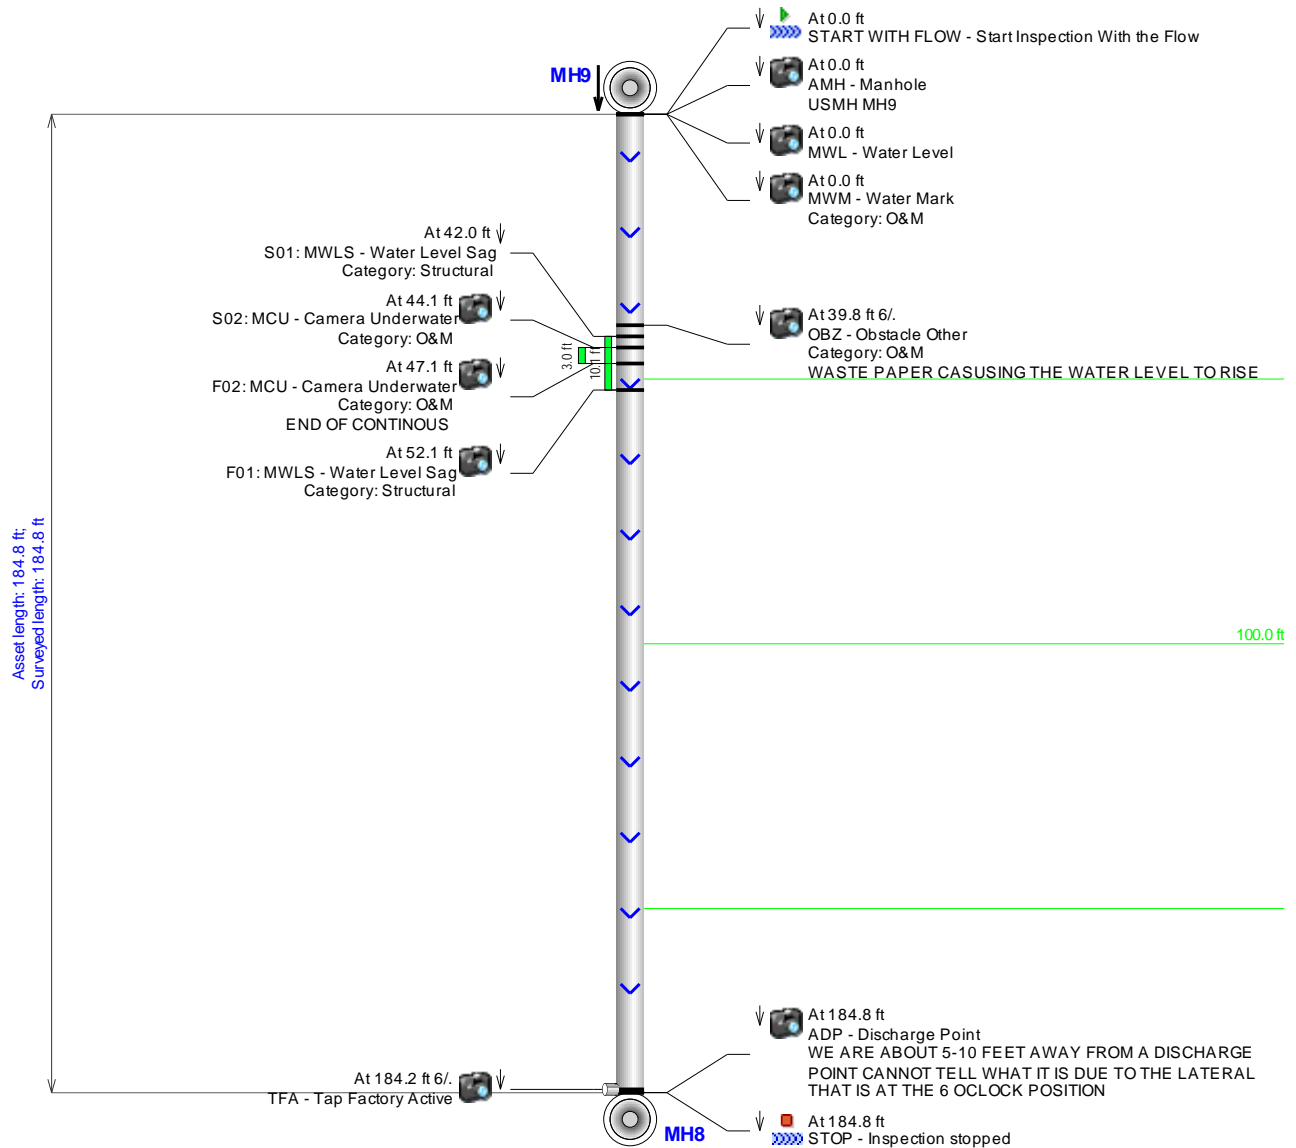
## Main Inspection with Pipe-Run Graph

Project Name: <b>CRAFTON HILLS COLLEGE</b>	Pipeline segment ref: <b>MH9-MH8</b>	City: <b>YUCAIPA</b>	Street: <b>CAMPUS DRIVE</b>
Start date/time: <b>9/29/2015</b>	Width: 	Height: <b>8</b>	Material: <b>RCP</b>
Direction: <b>Downstream</b>	Length surveyed: <b>184.8</b>	Surveyed by: <b>R.ZIEGLER</b>	Location code: <b>C</b>
			Weather: <b>1</b>
			Additional info:
