# SEWER SYSTEM MANAGEMENT PLAN

**San Bernardino Community College District**

June 2016

**Prepared by:  
ITF & Associates Inc.  
11278 Los Alamitos Blvd., #354  
Los Alamitos, CA 90720  
(800) 797-9483**

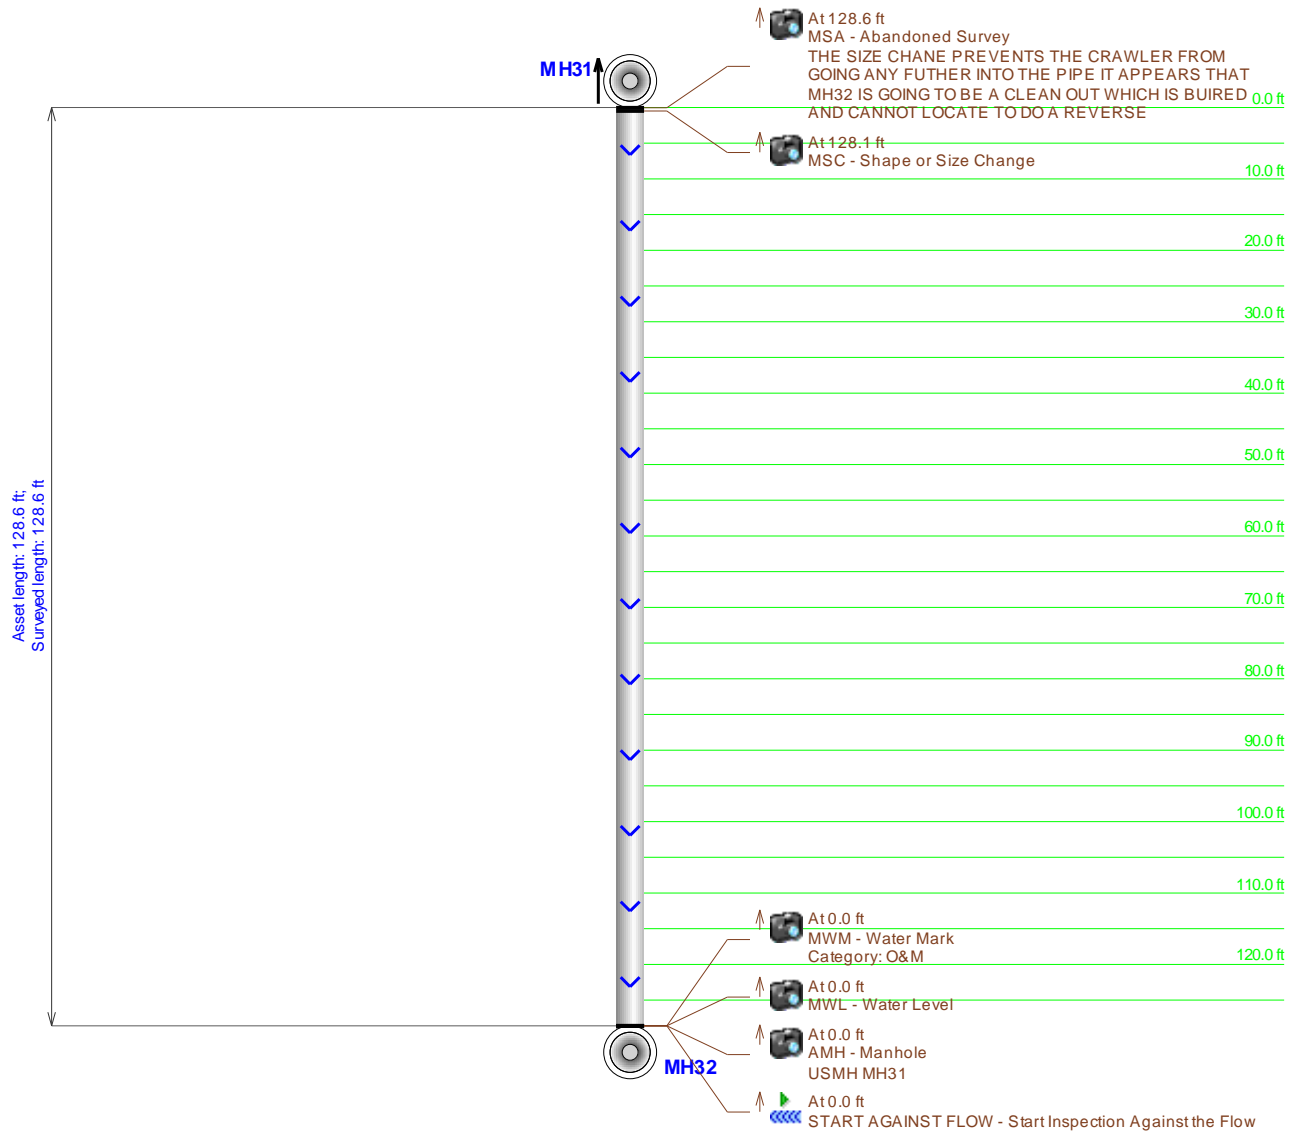
## Main Inspection with Pipe-Run Graph

Project Name: <b>CRAFTON HILLS COLLEGE</b>	Pipeline segment ref: <b>MH31-MH32</b>	City: <b>YUCAIPA</b>	Street: <b>CRAFTON HILLS MATIENCE ROAD</b>
Start date/time: <b>9/29/2015</b>	Width: <b></b>	Height: <b>8</b>	Material: <b>PVC</b>
Direction: <b>UPSTREAM</b>	Length surveyed: <b>128.6</b>	Surveyed by: <b>R.ZIEGLER</b>	Location code: <b>C</b>
		Weather: <b>1</b>	
Additional info: <b></b>

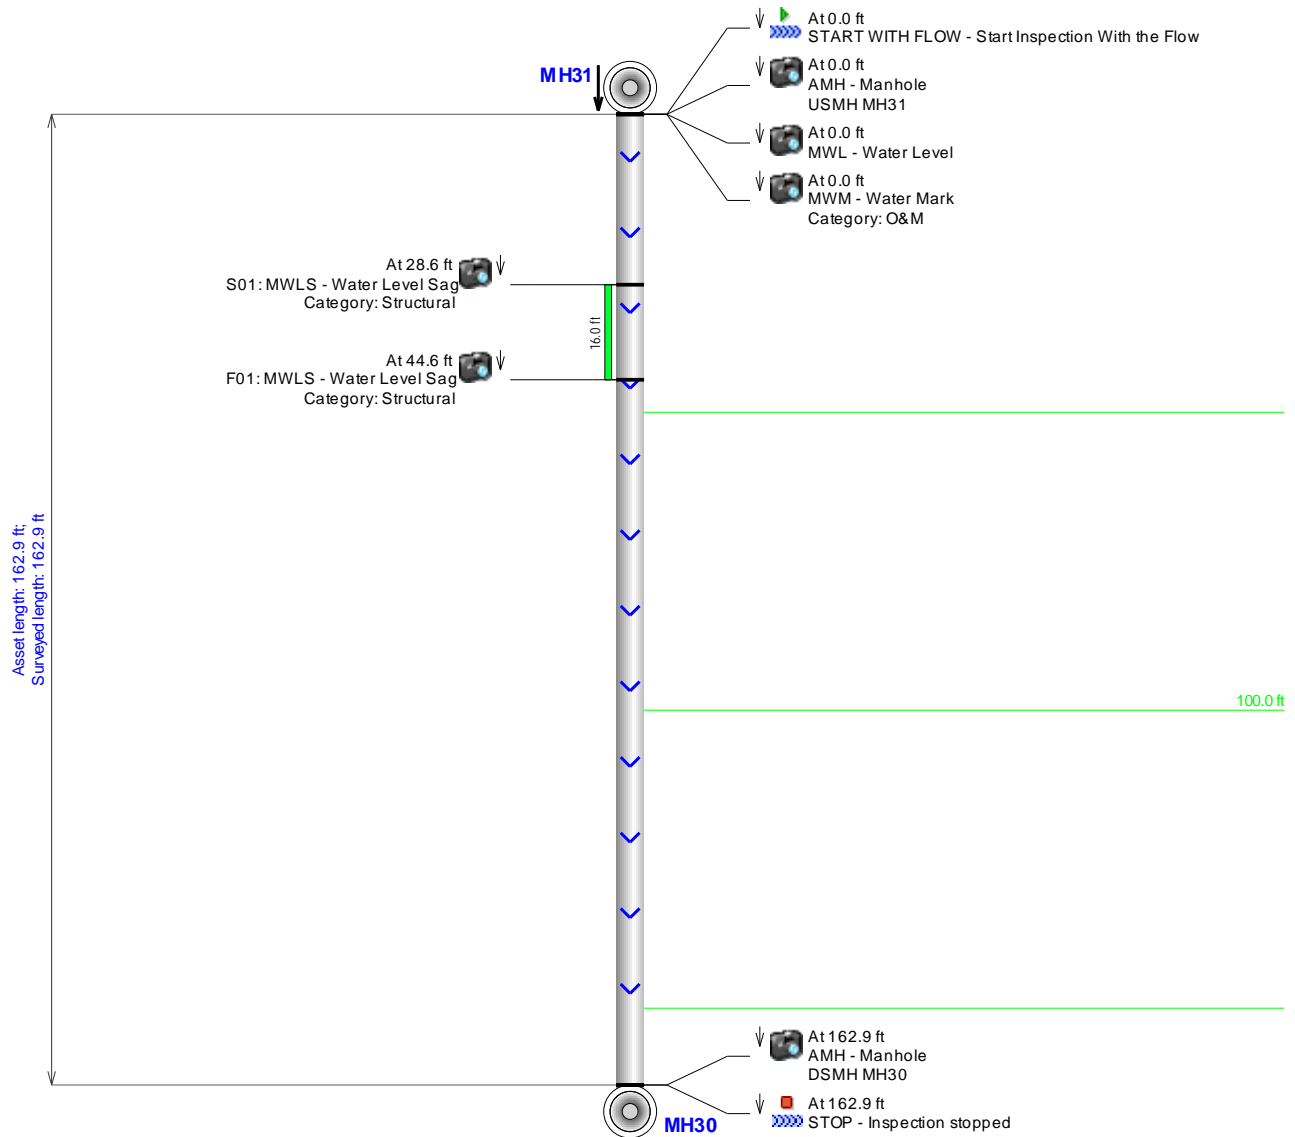
## Main Inspection with Pipe-Run Graph

Project Name: <b>CRAFTON HILLS COLLEGE</b>		Pipeline segment ref: <b>MH31-MH30</b>		City: <b>YUCAIPA</b>		Street: <b>MATIENCE ROAD</b>	
Start date/time: <b>9/29/2015</b>		Width: <b>8</b>		Material: <b>PVC</b>		Location code: <b>C</b>	
Direction: <b>Downstream</b>		Length surveyed: <b>162.9</b>		Surveyed by: <b>R.ZIEGLER</b>		Additional info:

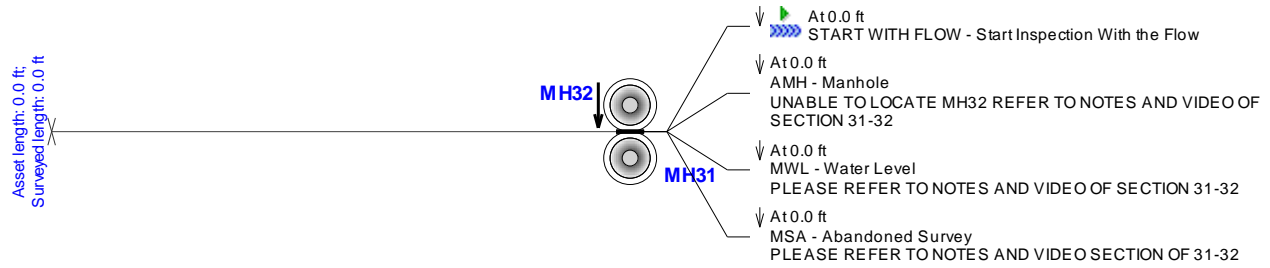
## Main Inspection with Pipe-Run Graph

Project Name: <b>CRAFTON HILLS COLLEGE</b>	Pipeline segment ref: <b>MH32-MH31</b>	City: <b>YUCAIPA</b>	Street: <b>CRAFTOM HILLS MATIENCE ROAD</b>
Start date/time: <b>9/29/2015</b>	Width: <b></b>	Height: <b>8</b>	Material: <b>PVC</b>
Direction: <b>Downstream</b>	Length surveyed: <b>0.0</b>	Surveyed by: <b>R.ZIEGLER</b>	Additional info: <b>MH32 IS BURIED NOT ABLE TO LOCATE POSSIBLE A C/O FROM VIDEO MH31-MH32</b>
			Location code: <b>C</b>
			Weather: <b>1</b>
